# BERKELEY FIRE DEPARTMENT

## INCIDENT INVESTIGATION REPORT

On Friday, November 18, 2011 at 2048 hours, Berkeley Fire units responded to reported heat detector activation from the elevator mechanical room at 2441 Haste Street in Berkeley. Engine 5 (Captain Roman) was first to arrive on scene and reported light smoke coming from the (Haste Street) A-side basement. Engine 5 crews advanced an attack-line into the basement from the west-side alley (B-side) and located the seat of the fire inside the elevator mechanical control room. Captain Roman reported that he was able to knock down and extinguish the fire within that room. He and his firefighter retreated from the structure and were advised by Engine-1 (Captain Cavagnaro) that active fire was still burning on the second floor through the window of the Haste Street (A-side). At that point the fire escalated to a second alarm; and eventually escalated to a 5 alarm fire which resulted in complete destruction of the building.

### ORIGIN AND CAUSE FIRE INVESTIGATION

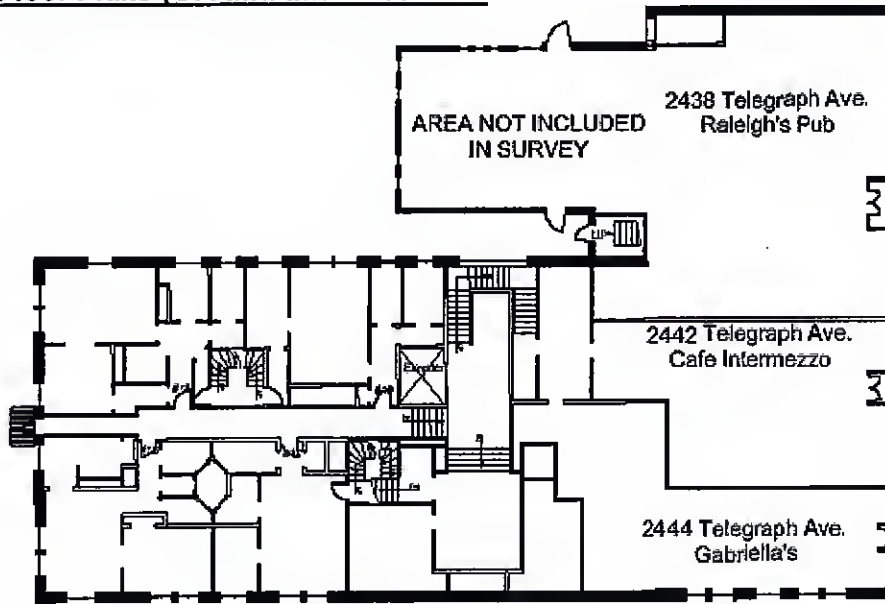
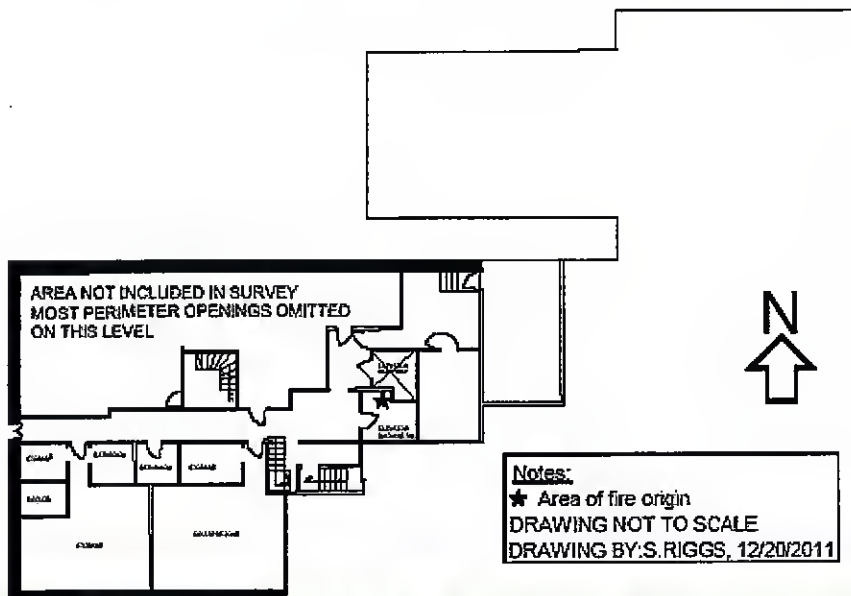
### 2441 Haste Floor Plans (Ground and First Floor)

**Notes:**  
 ★ Area of fire origin  
 DRAWING NOT TO SCALE  
 DRAWING BY: S. RIGGS, 12/20/2011

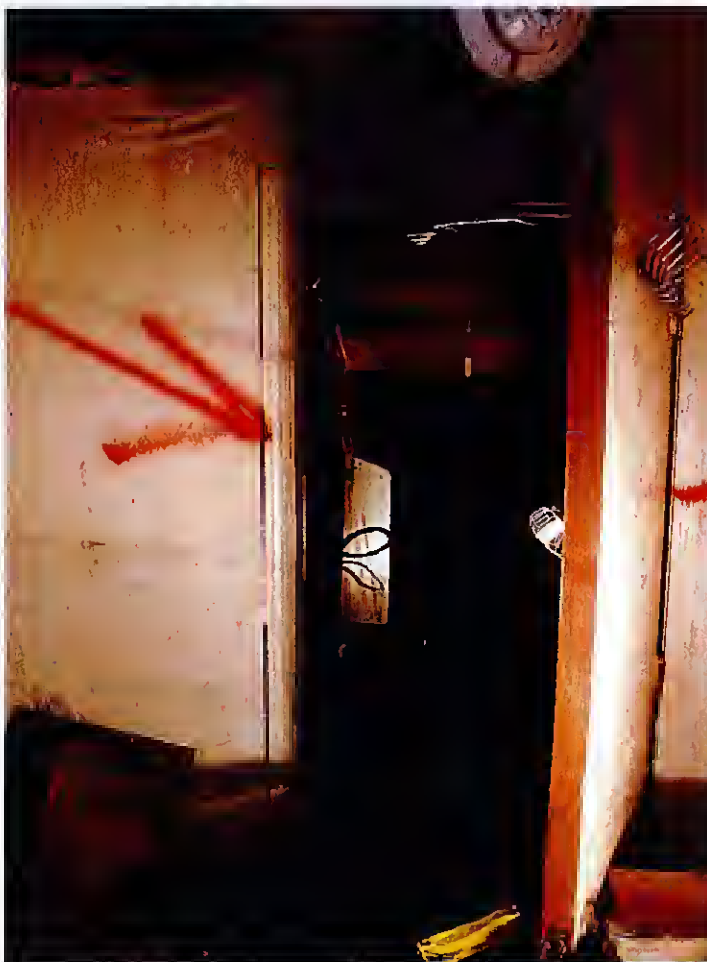
**Figure 2- Image 48 (file DSCF0402)** The elevator machine room door as seen from the ground floor center service corridor. This door is visible at the end of the corridor facing the camera in images 13/14 and 44/45. Smoke staining can clearly be seen above the door header and is consistent with smoke and heat venting from the machine room into the corridor. The fire in this space was the first attacked by the first responding engine company

- 47 DSCF0401.jpg Photograph of veneer brick used on the Haste and Telegraph faces of the structure. A measuring tape has been added for scale.
- 48 DSCF0402.jpg The elevator machine room door as seen from the ground floor center service corridor. This door is visible at the end of the corridor facing the camera in images 13/14 and 44/45. Smoke staining can clearly be seen above the door header and is consistent with smoke and heat venting from the machine room into the corridor. The fire in this space was the first attacked by the first responding engine company. The orange paint markings have been added by the insurance company's private fire investigators.[image by S.Riggs on 11/28/2011]

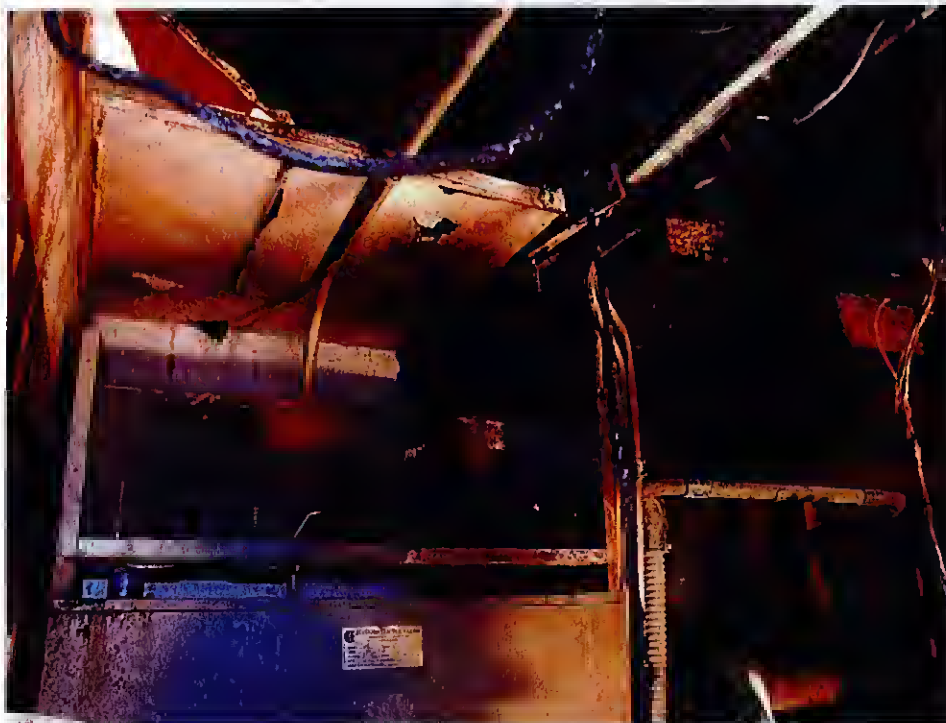
Inside the machine room doorway on the north wall at approximately 6' off of the floor I observed a distinct V burn-pattern extending up and outwards from the location of two elevator resistors associated with the elevator motor control equipment. A protective metal cabinet face had been removed by Fire Cause Analysis exposing the two resistors. Immediately to the left and right below the resistors, the fire, smoke and heat damage lessened significantly. Directly above the resistors I observed the V-burn pattern that continuously burned up and outward and extended through the opening in the ceiling up into the attic area above the room. It is my opinion the fire initially traveled from the elevator mechanical room up into the basement attic area to eventually to the other locations of the building. **(See appendix's #1 & #5, for detailed floor plan sketch/drawing and photographs).**

Figure 3- Image 49 (file DSCF0403.jpg). The north wall of the elevator machine room showing the top of elevator control and power equipment and the elevator hoist equipment on the right. The wood at the hoistway header is burned in a vee pattern that suggests more intense heat and heat movement from the direction of the controller. The metal access panel which normally encloses the upper portion of the cabinet has been removed. The two cylindrical control resistors are visible mounted within the metal cabinet. A circular heat pattern is visible above the general location of the resistors. Multiple vee shaped heat patterns can be seen bracketing the location of the resistors in the right-rear corner of the metal cabinet. An additional heat pattern (evidenced by the rusting of the metal enclosure) is visible directly below the resistors.

- 49 DSCF0403.jpg The north wall of the elevator machine room. An elevator motor pulley and the elevator hoist cable can be seen on the right side of the image. The elevator control and power equipment are on the left side of the image. The wood at the hoistway header is burned in a vee pattern that suggests more intense heat and heat movement from the direction of the controller. The metal access panel which normally encloses the upper portion of the cabinet has been removed by the private investigators. The two cylindrical control resistors are visible mounted within the metal cabinet. A circular heat pattern is visible above the general location of the resistors. Multiple vee shaped heat patterns can be seen bracketing the location of the resistors in the right-rear corner of the metal cabinet. An additional heat pattern (evidenced by the rusting of the metal enclosure) is visible directly below the resistors. [image by S.Riggs on 11/28/2011]

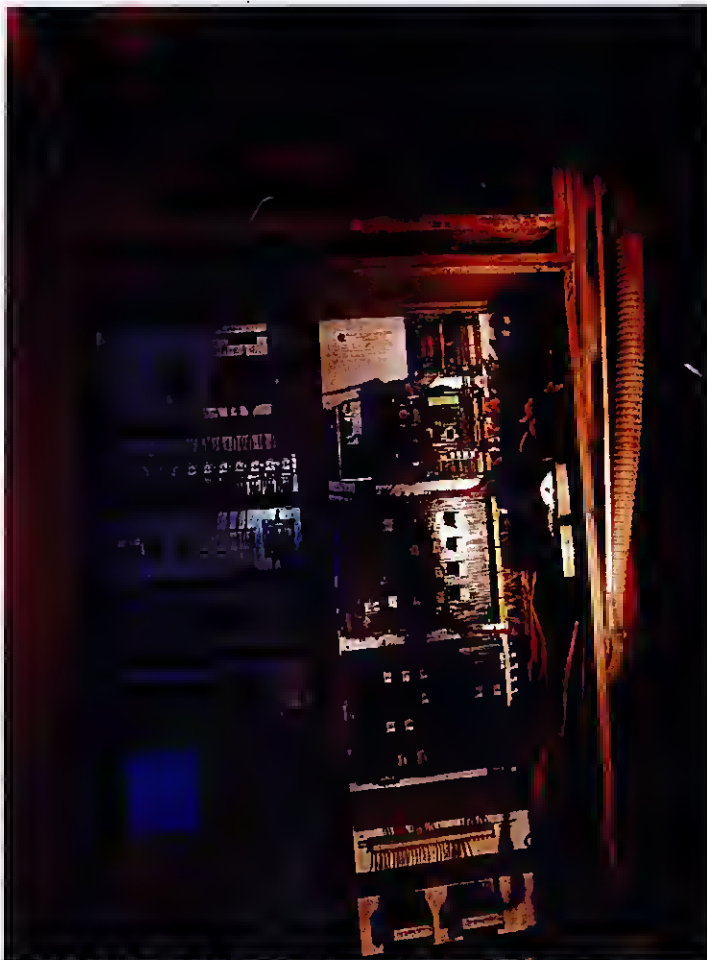
Figure 4- Image 65 (file DSCF0419.jpg) The elevator controller with the main access panel removed. There is no indication of heat or fire damage within the main equipment enclosure.

- 64 DSCF0418.jpg Utility space at the top of the stairs shown in image 61/DSCF0416.jpg. [image by S.Riggs on 11/28/2011]
- 65 DSCF0419.jpg The elevator controller (in the elevator machine room) with the main access panel removed. There is no indication of heat or fire damage within the main equipment enclosure. The heat pattern below the resistors is visible on the cabinet of the upper compartment. The lack of heat damage in the main controller cabinet suggests heat movement from above this main controller compartment. [image by S.Riggs on 11/28/2011]

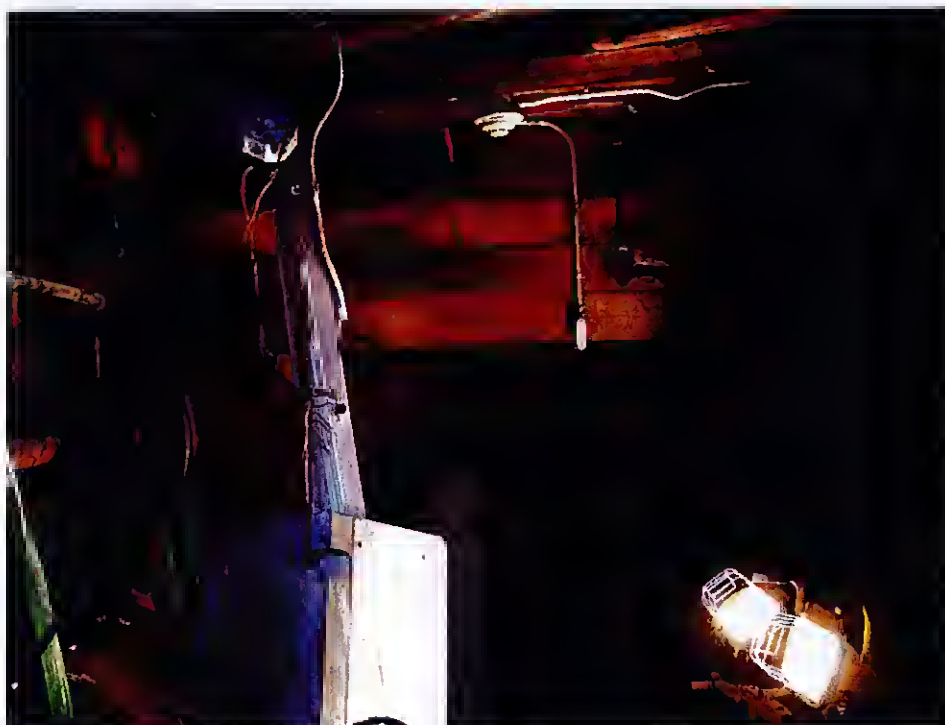
The undersides of much of the remaining wood ceiling planks (the side exposed to the machine room) were either undamaged or lightly damaged by smoke and heat. The upper surfaces showed heavy alligating and mass loss. The upper edges of the planking were well rounded. (See appendix's #1 & #5, for detailed floor plan sketch/drawing and photographs).

Figure 6- Image 52 (file DSCF0406.jpg). The ceiling of the elevator machine room looking towards the east wall. The fire alarm heat detector can be seen mounted on the ceiling. Much of the ceiling is intact and unburned. Ceiling areas that are burned through on the left show much more significant damage to the top surfaces of the ceiling boards, suggesting that fire development was greater and/or earlier in the space above the ceiling.

- 52 DSCF0406.jpg The ceiling of the elevator machine room looking towards the east wall. The fire alarm heat detector can be seen mounted on the ceiling. Much of the ceiling is intact and unburned. Ceiling areas that are burned through on the left show much more significant damage to the top surfaces of the ceiling boards, suggesting that fire development was greater and/or earlier in the space above the ceiling. [image by S.Riggs on 11/28/2011]
